TSB 2016-1002 Level: 2

Topic	Overtightening of 4-in-1 Ball Valve Tool (Core Removal Tool) can lead to failure and potential venting of the system under service.
Affected Units	4-in-1 Ball Valve Tool, All Models
Resolution	This tool should be tightened by hand only as shown in procedure below.

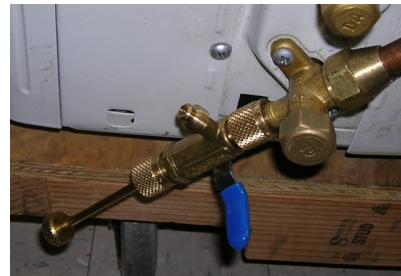
Figure 1

1. ASSURE PROPER ALIGNMENT AND ACCESS TO THE SIDE PORT AND VALVE HANDLE BEFORE TIGHTENING THE TOOL (Figure 1)

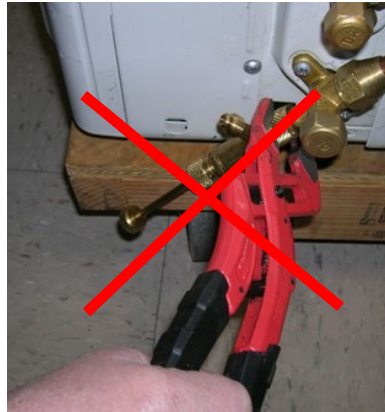
**Figure 4**

In testing, it was determined that over-tightening this tool during installation can cause failure resulting in the potential venting of the system under service.

1. TIGHTEN WITH ANY TOOL
(Figure 4)

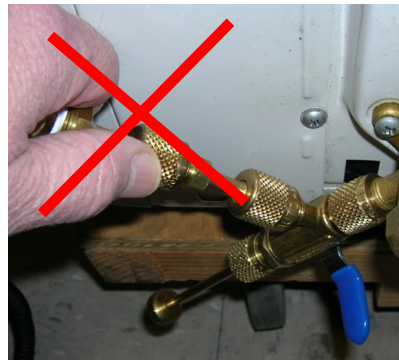
**Figure 5**

2. USE ANY ATTACHMENT TO THE
SIDE PORT FOR ADDITIONAL
LEVERAGE TO TIGHTEN THE
TOOL
(Figure 5)
